# Long-Term Performance of Corrosion Inhibitors Used in Repair of Reinforced Concrete Bridge Components

PUBLICATION NO. FHWA-RD-01-097

JULY 2003

9. Performing Organization Name and Address CONCORR, Inc. 44633 Guilford Drive, Suite 101 Ashburn, VA 22011		11. Contract or Grant No. DTFH61-94-C-00054

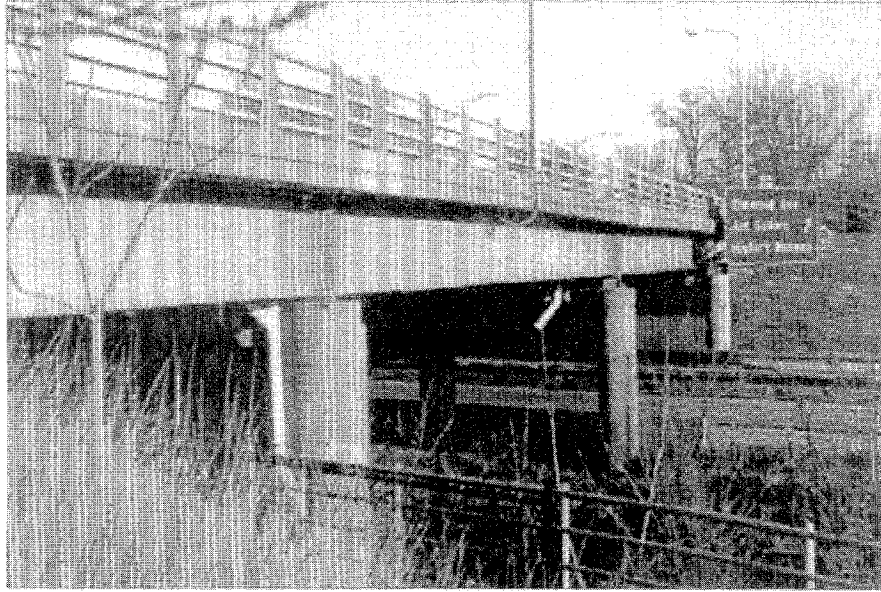
**Figure 2-1. General view of the Elmwood Avenue bridge over NY Route 198, Buffalo, NY.**

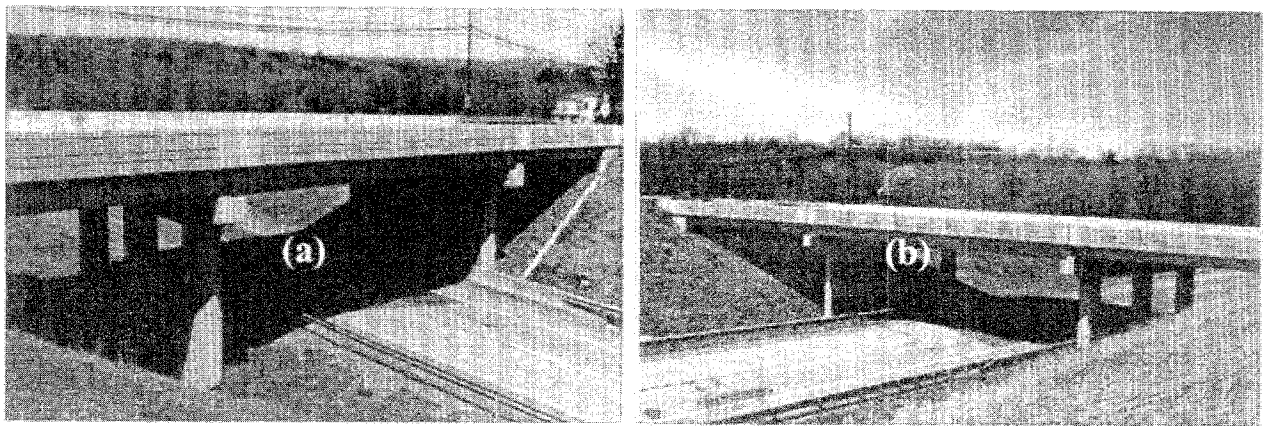
**Figure 3-1. General views of the SR 2042 bridge structures over I-81:  
(a) west bridge and (b) east bridge.**

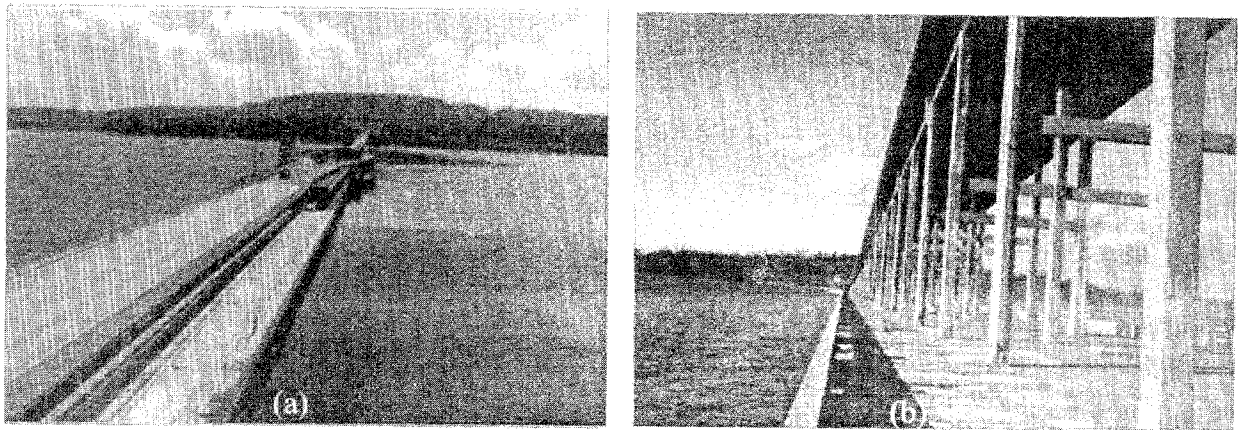
**Figure 4-1. General views of the Hood Canal bridge.**

The floating bridge was constructed in 1961. In 1979, the western half of the bridge sank in a storm and was subsequently replaced. Corrosion of the concrete reinforcing steel in the pontoon decks and substructure members is evident throughout the older eastern half of the floating bridge. Previous repairs to the eastern half of the bridge included patching of the pontoon decks, columns, and crossbeams, and the coating of these surfaces with epoxy. Even though the pontoon decks are about 1.5 m above high tide, they are constantly exposed to wind-blown brackish water mist, especially on the southern side of the decks. Water tends to pond on the deck surface. As a result, corrosion has continued unabated in the original and repaired concrete areas.

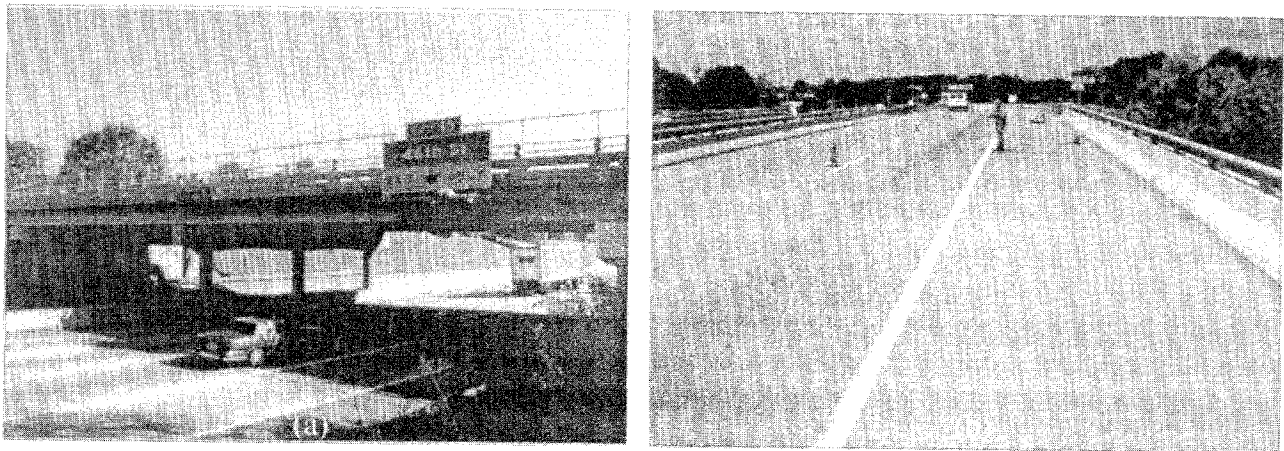
**Figure 5-1. TH-3 over the Southview Boulevard bridge: (a) structure and (b) deck.**

The deck was rehabilitated and overlaid with a 5.08-cm Low-Slump Dense Concrete (LSDC) mix in May-June 1992. About 3.81 cm of the original chloride-contaminated concrete was milled off to the top layer of reinforcing steel and unsound areas were removed with a pneumatic hammer. The entire deck surface was sandblasted to remove laitances prior to placement of the overlay.
